Simon Pryce Arboriculture

Report

Site: BAM Estate Gardens, London, NW3

Subject: Update of tree survey, including test boring of two trees

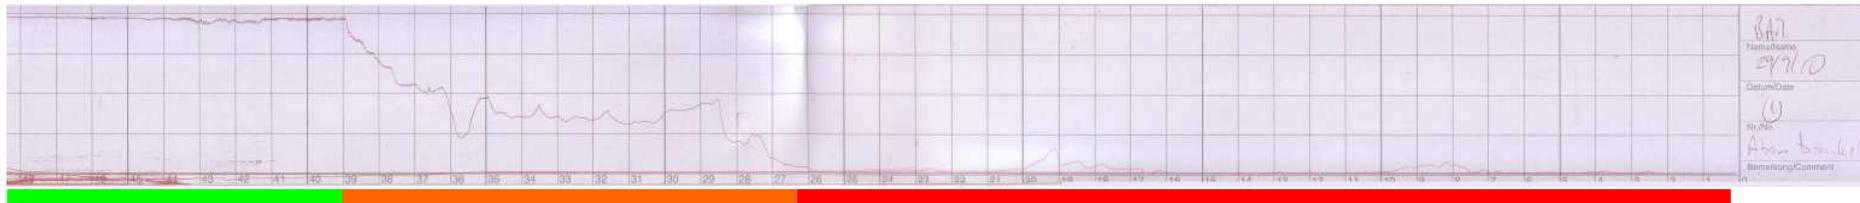
Tree 12, Norway maple, test bore no.1. Drilled from north side just above *Ganoderma* brackets, soft wood setting.

sound wood 39cm significant decay 26cm minimal resistance, severe decay or hollow

Electronic recording was not made, so this is an annotated scan of the paper trace from the instrument, using the same colour coding as the electronic ones on the following pages.

- 2.3 This has well developed *Ganoderma* brackets growing at the base on the north side and, when inspected, they were producing spores, indicating that they had been growing actively, i.e. decaying the wood, for some time. The tree was test bored from three directions, the first one did not record electronically, so the paper trace from the machine has been scanned and annotated. The charts are attached at the end of the report. This reveals extensive decay, especially just above the brackets, which is typical of this fungus. There is some sound wood, so the tree is probably not in immediate danger of failing but it is in a well used part of the garden, indicated by soil compaction affecting some others nearby, and the decay will inevitably spread. Therefore the tree should be felled for safety without undue delay.

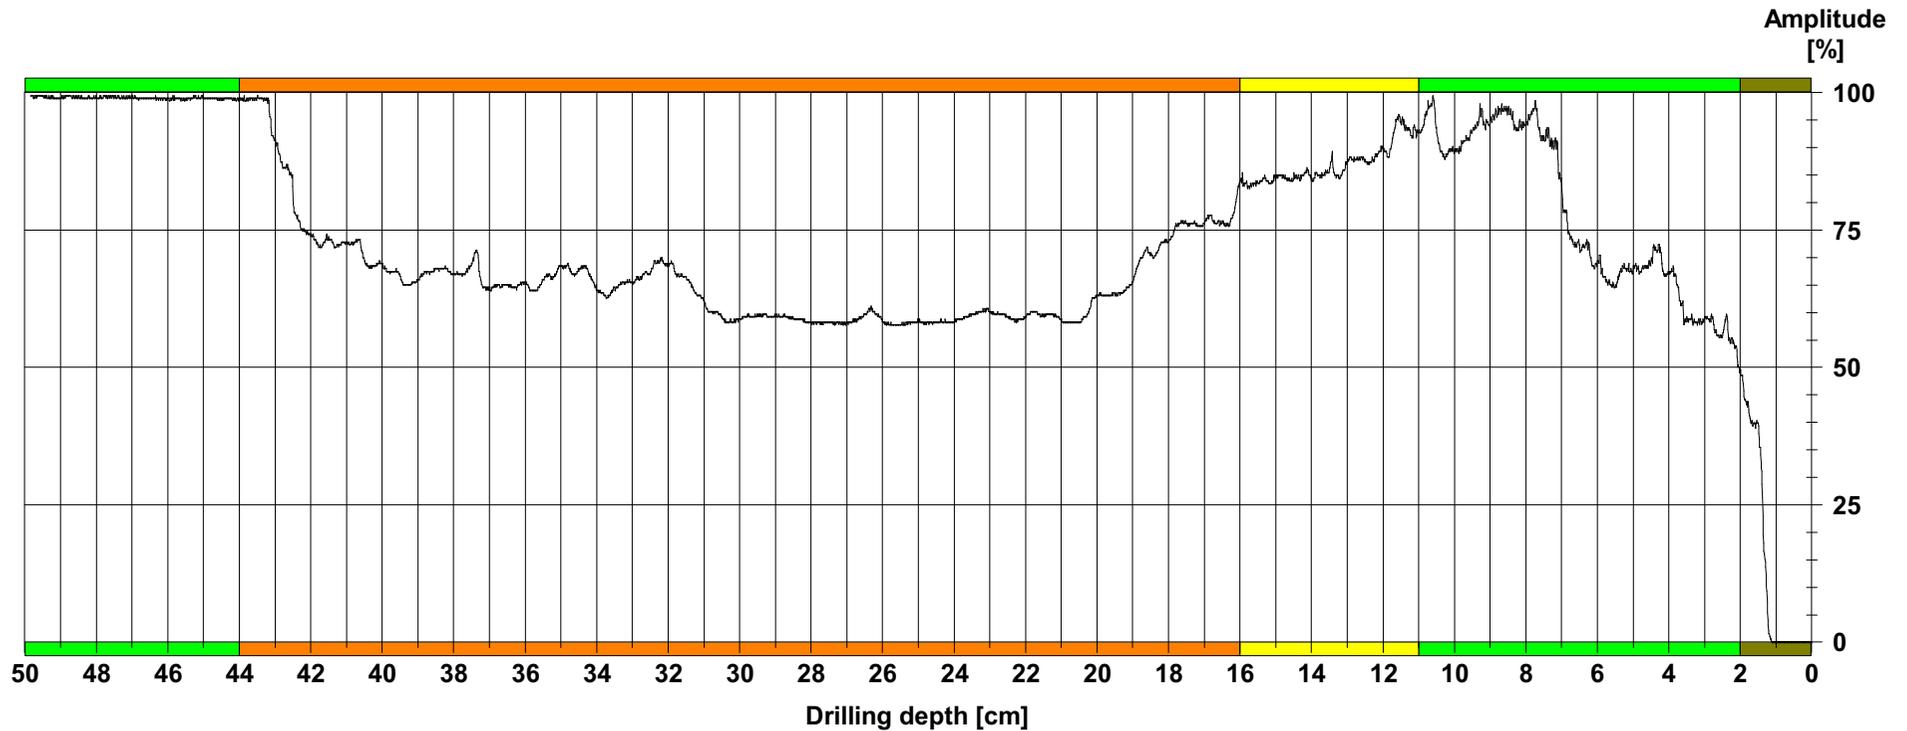
From	0,0 cm	to	2,0 cm	:	Bark
	From	2,0 cm	to	11,0 cm	:	Sound wood
	From	11,0 cm	to	16,0 cm	:	Incipient decay
	From	16,0 cm	to	44,0 cm	:	Decay
	From	44,0 cm	to	50,0 cm	:	Sound wood
	From	0,0 cm	to	0,0 cm	:

Drilled just above brackets from west side, shows some sound outer wood but extensive internal decay. Soft setting

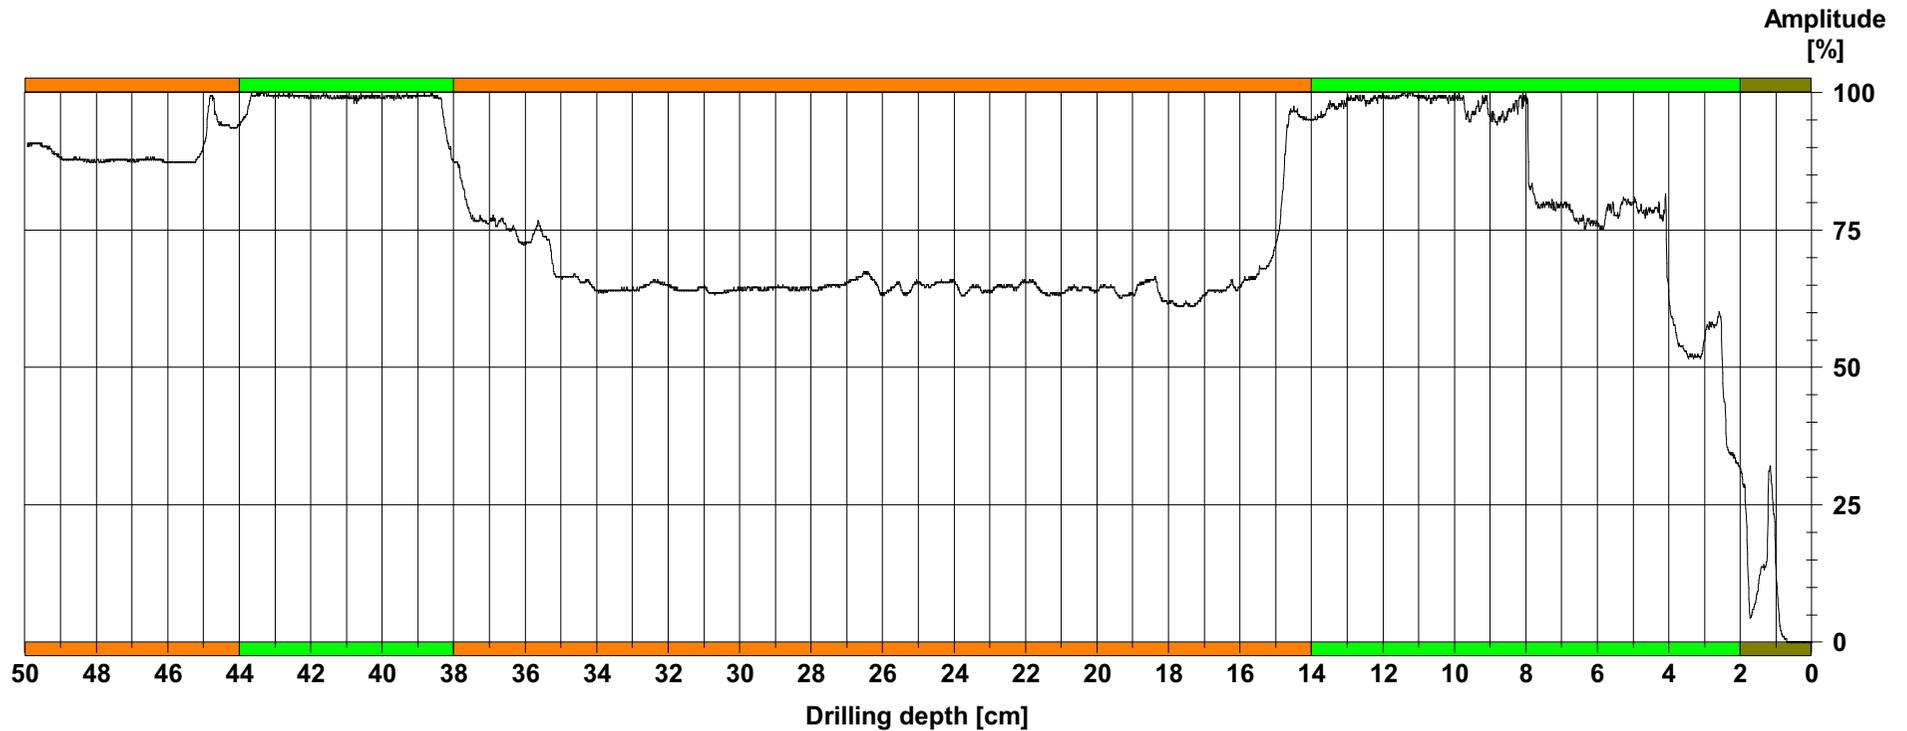
From	0,0 cm	to	2,0 cm	: Bark
	From	2,0 cm	to	14,0 cm	: Sound wood
	From	14,0 cm	to	38,0 cm	: Decay
	From	38,0 cm	to	44,0 cm	: Sound wood
	From	44,0 cm	to	50,0 cm	: Decay
	From	0,0 cm	to	0,0 cm	:

Drilled from south side opposite Ganoderma brackets and higher, shows extensive decay with some islands of sound wood. Soft setting

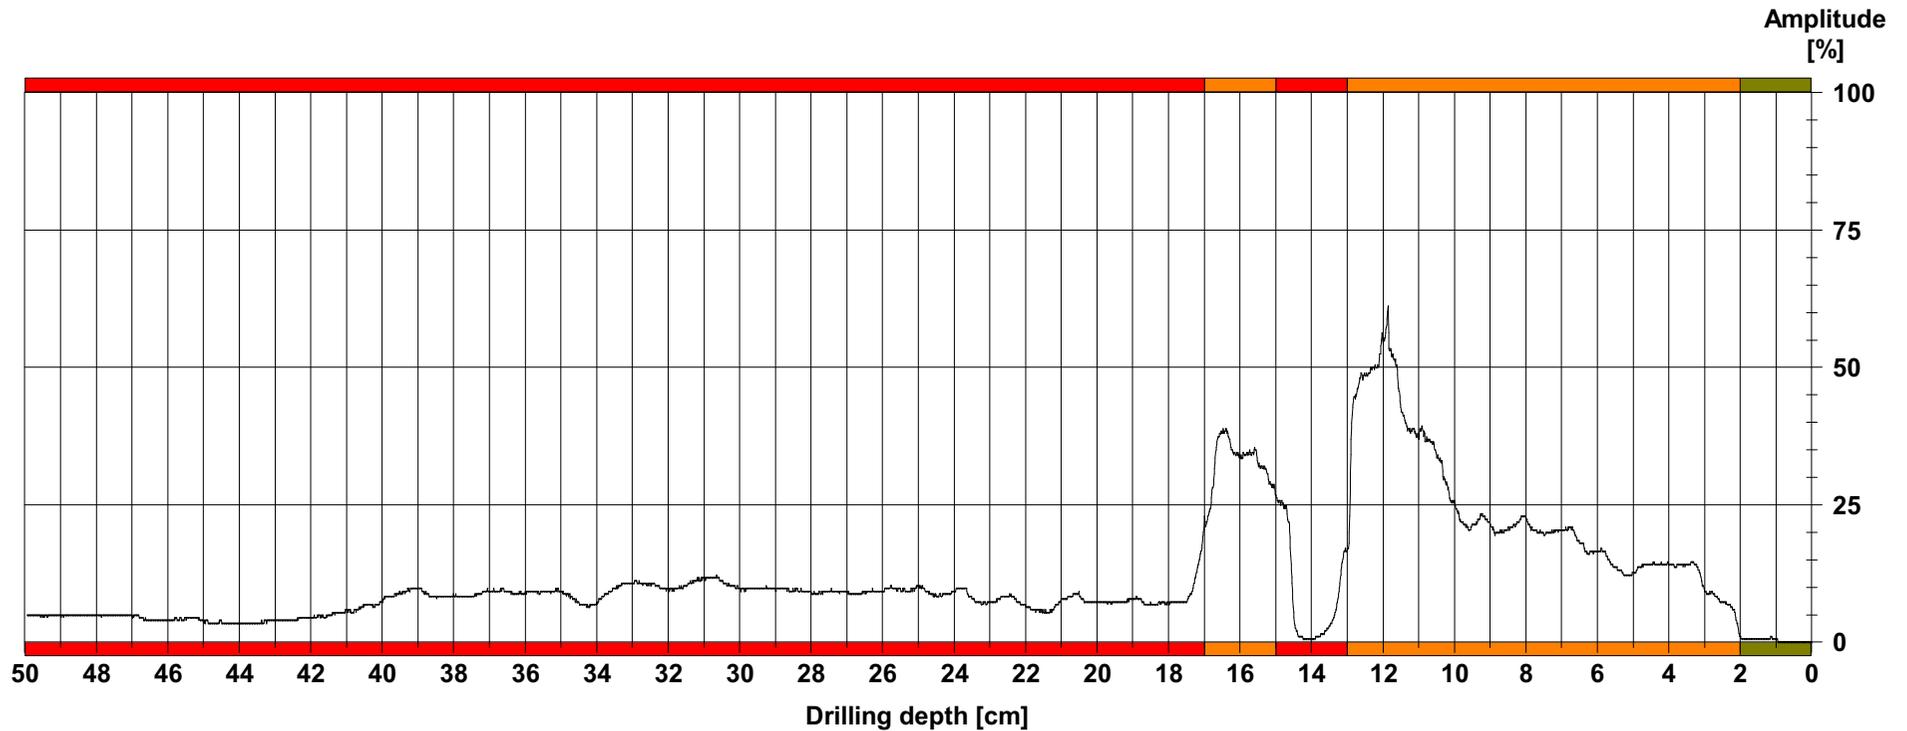
- 2.4 This was noted to have an immature fruiting body of *Kretschmeria* [formerly *Ustulina*] *deusta* at the base in 2006 and recommended for reinspection. By 2010 this had developed into a cavity extending under most of the tree's base. Although that alone indicates that the tree should be felled it was also test bored above this [chart attached], revealing severe decay extending up the trunk. This tree is in a more remote location than tree 12 but is this part of the garden is still used and it near a boundary. It is in far worse condition than tree 12 and should be felled for safety without delay.

■	From	0,0 cm	to	2,0 cm	:	Bark
■	From	2,0 cm	to	13,0 cm	:	Decay
■	From	13,0 cm	to	15,0 cm	:	Advanced decay
■	From	15,0 cm	to	17,0 cm	:	Decay
■	From	17,0 cm	to	50,0 cm	:	Advanced decay
□	From	0,0 cm	to	0,0 cm	:

Drilled on soft wood setting well above cavity at base.
 Typical of advanced decay by Kretschmeria, major loss of wood strength and texture
